# Debris/Ice/TPS Assessment and Integrated Photographic Analysis for Shuttle Mission STS-59

DEBRIS/ICE/TPS ASSESSMENT  
AND  
INTEGRATED PHOTOGRAPHIC ANALYSIS  
OF  
SHUTTLE MISSION STS-59

April 9, 1994

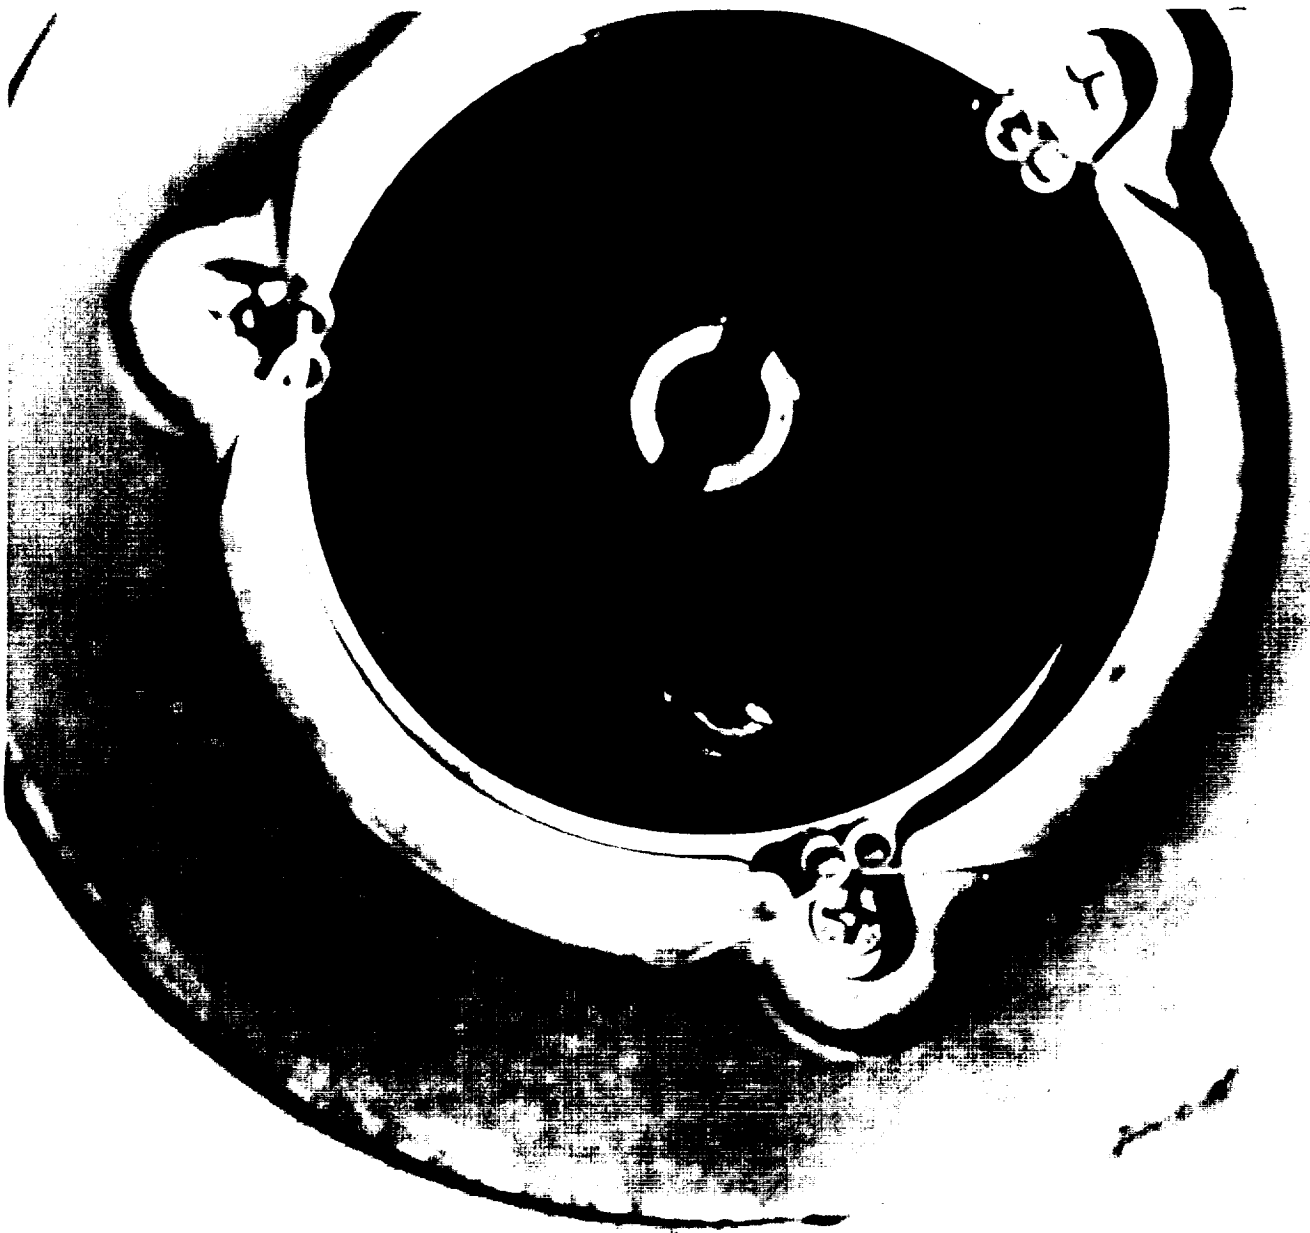
The EO-2 debris plunger was obstructed by ordnance debris

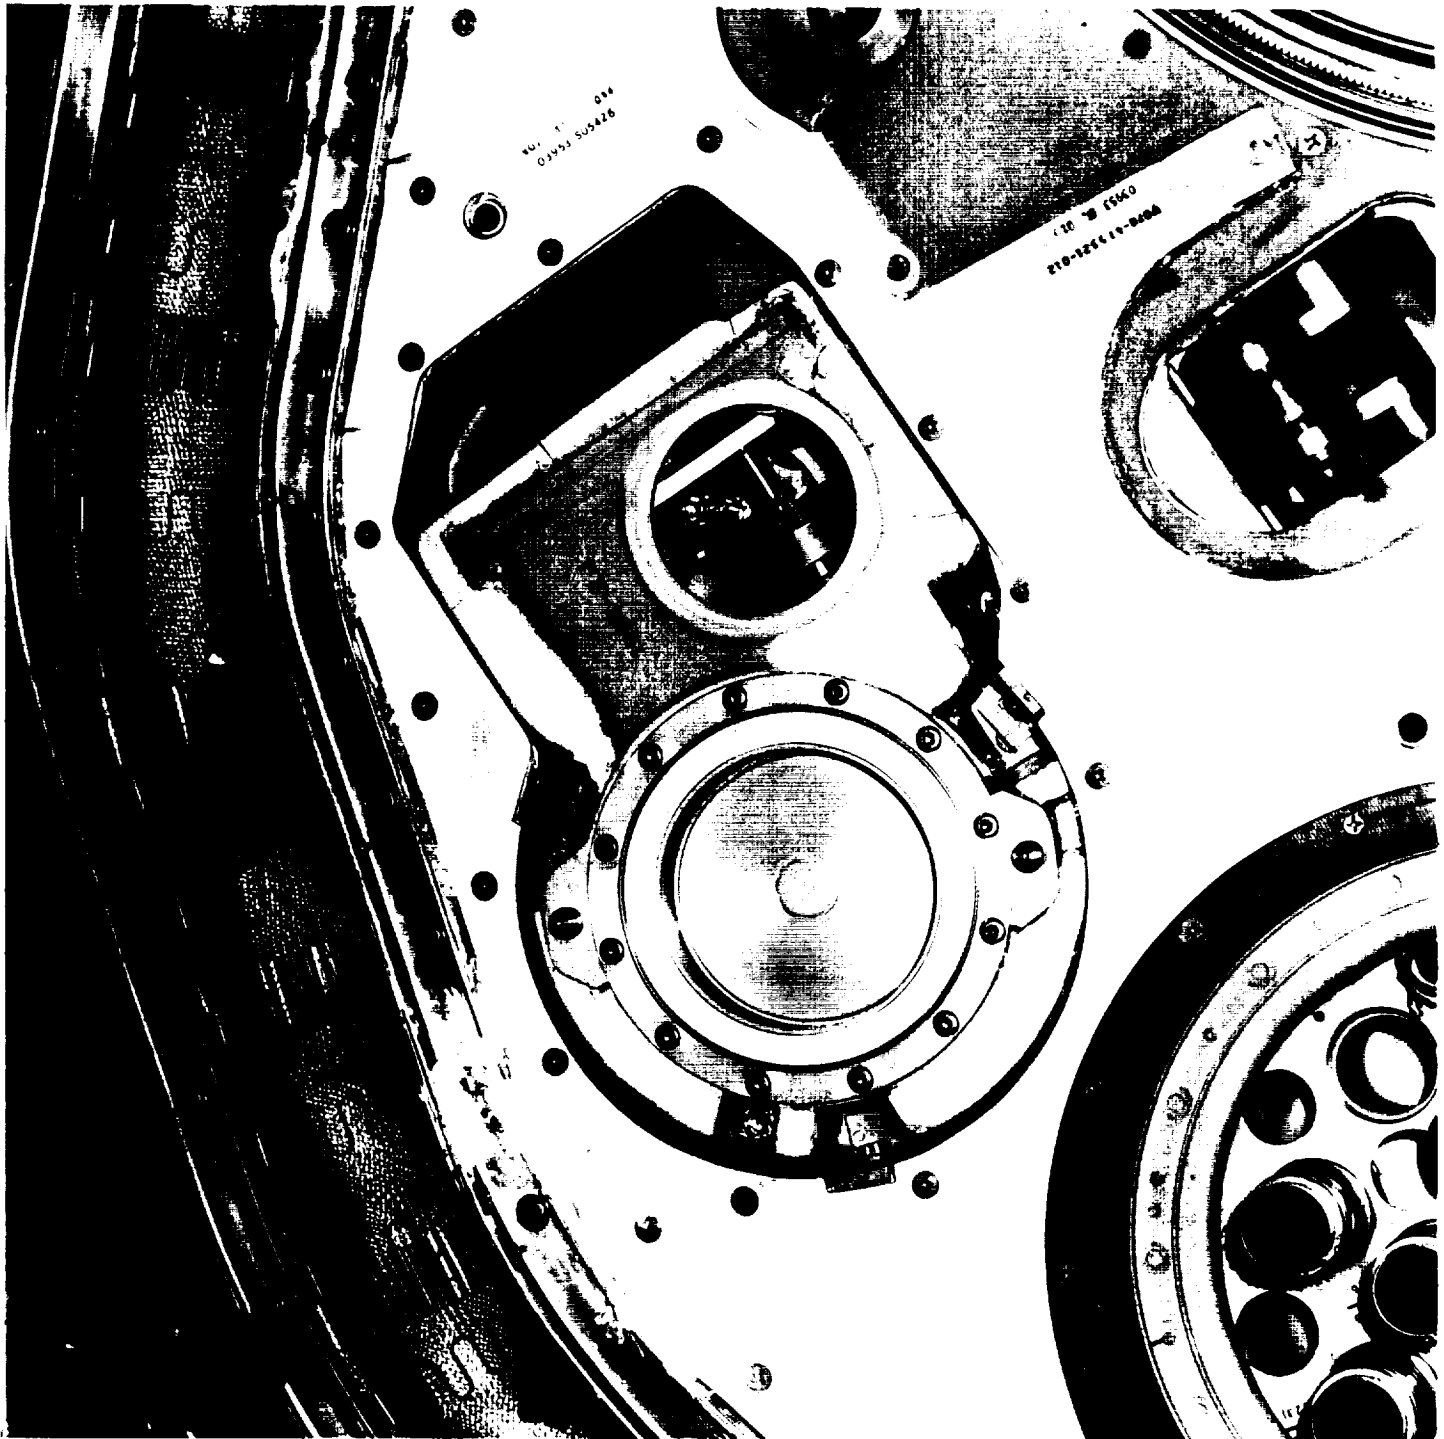
A small amount of white RTV and ET foam, but no red purge seal, adhered to the LH2 ET/ORB umbilical plate near the 4-inch line.

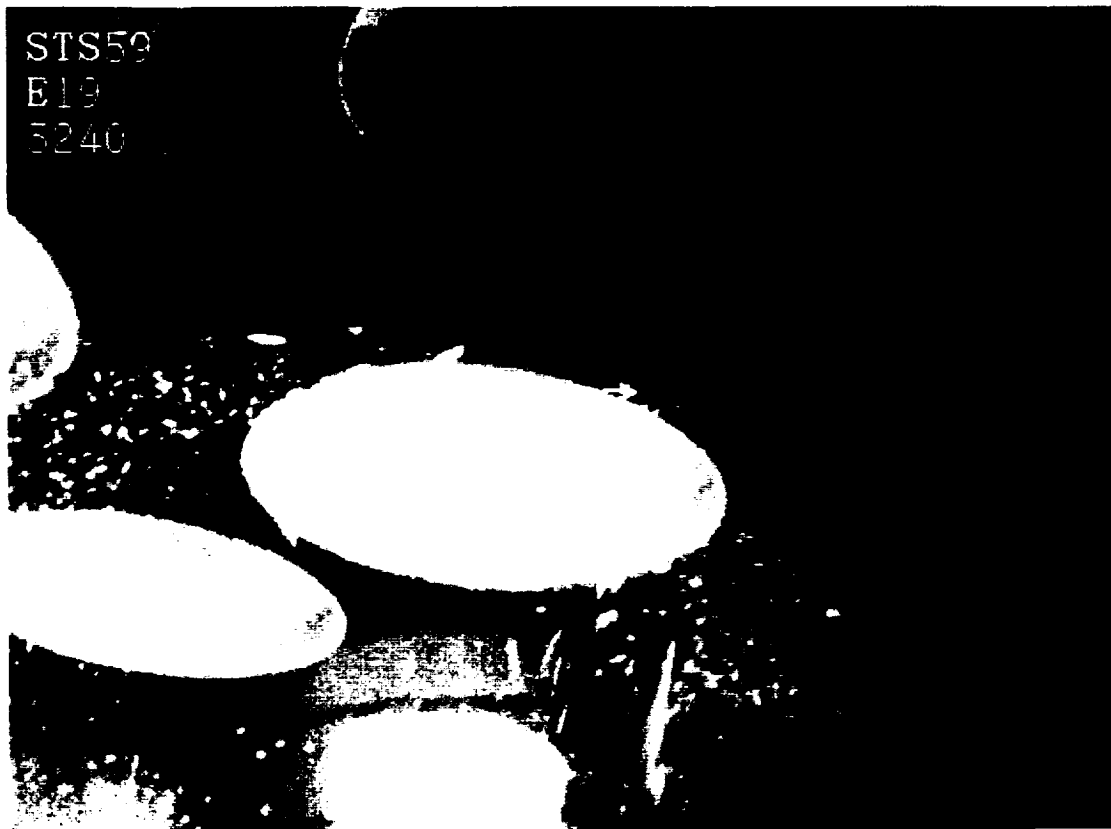
One piece of debris fell from the LO2 TSM disconnect area at T-1.6 seconds and struck the SSME #3 bell near the rim at the 3 o'clock position. The debris then fell aft into the SSME plume. No damage was detected to the vehicle. No follow-up action was requested.

**Figure 2.1.1.1** White Debris (Ice) from the LO2 TSM Disconnect Area Strikes SSME #3 Bell Rim at T-1.6 Seconds  
(Camera E-19, Frame 3240)
